Failure analysis of corroded steel surface

Root cause assessment using the Axia ChemiSEM

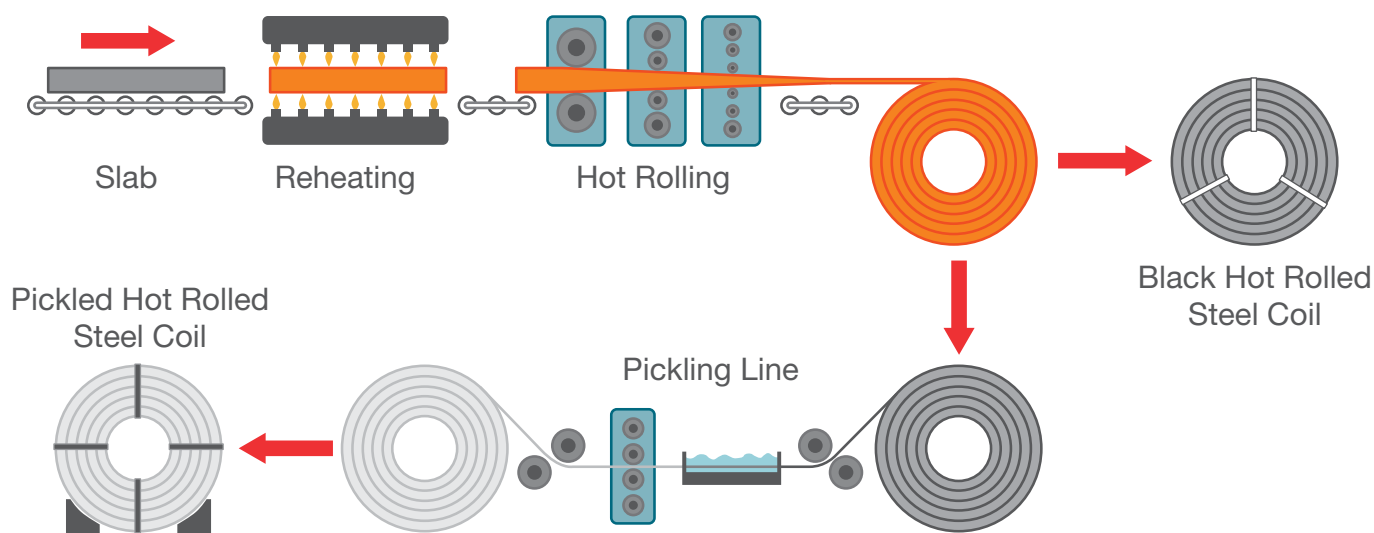
Figure 1. Hot-rolled steel sheet production process.

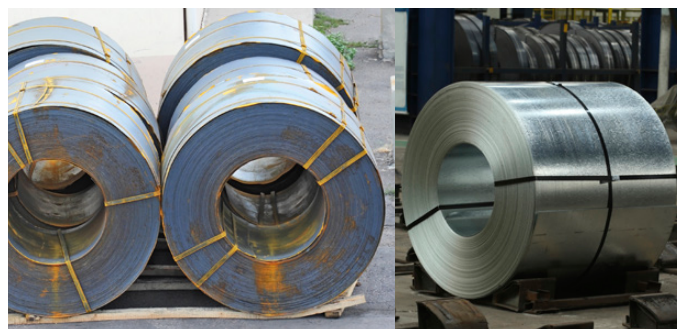
Figure 2. Hot-rolled coils or "black bands" in the left image show black oxide scale formed during reheating and red rust which formed at ambient temperature. The right image shows a hot-rolled steel coil after pickling.

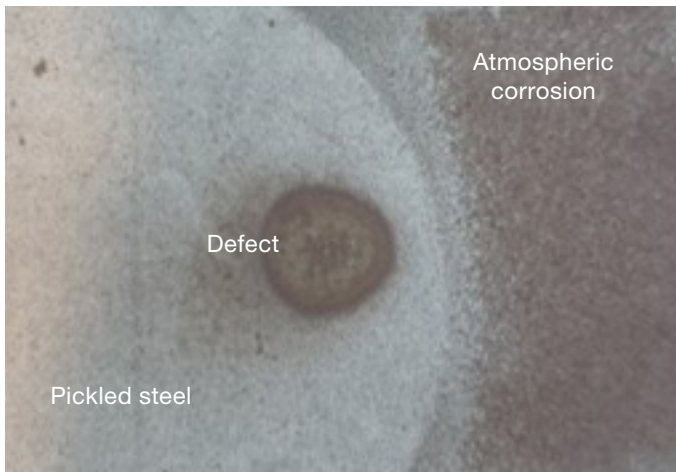
Figure 3. Defective sample.

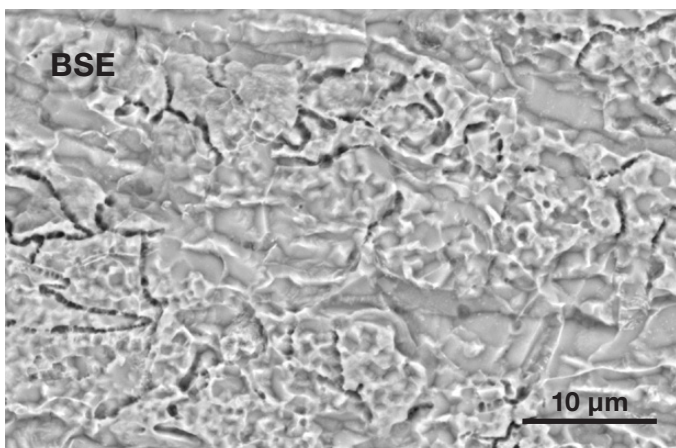
Figure 4. Typical surface of an etched steel (Acc voltage 15 keV, beam current 0.44 nA).

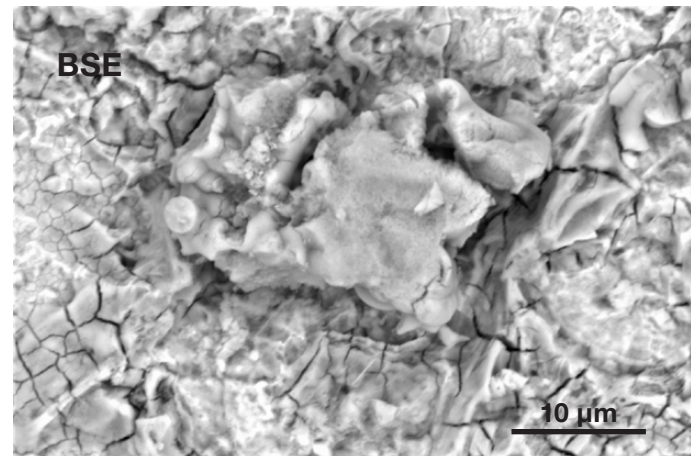
Figure 5. Secondary electron image (top) acquired inside the defective area. It shows the presence of a particle, higher than the surrounding surface, confirming it can be identified as a foreign object. Backscattered electron image (bottom) shows the compositional contrast (Acc voltage 15 keV, beam current 0.44 nA).

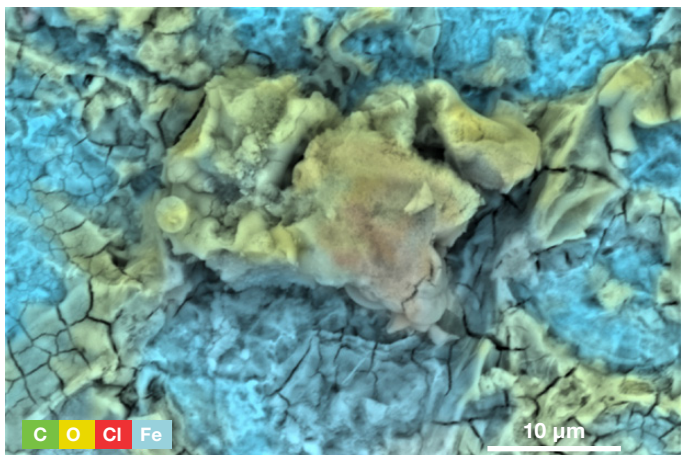
Figure 6. ChemiSEM image of the area displayed in Figure 5 (Acc voltage 15 keV, beam current 0.44 nA, acquisition time 60 s).

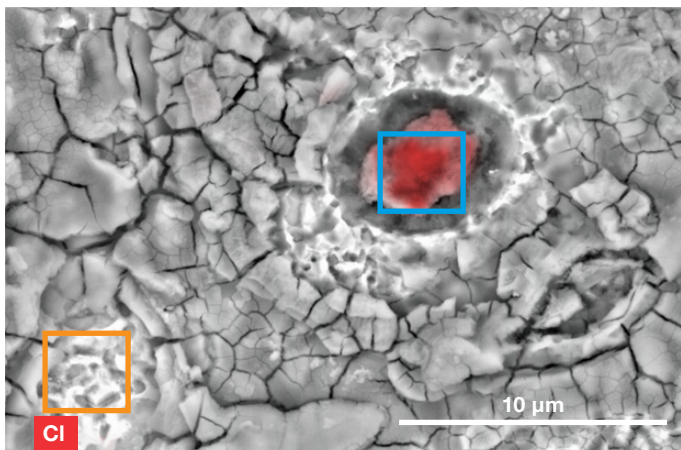
Figure 8. ChemiSEM image showing the two areas used for the region analyses.

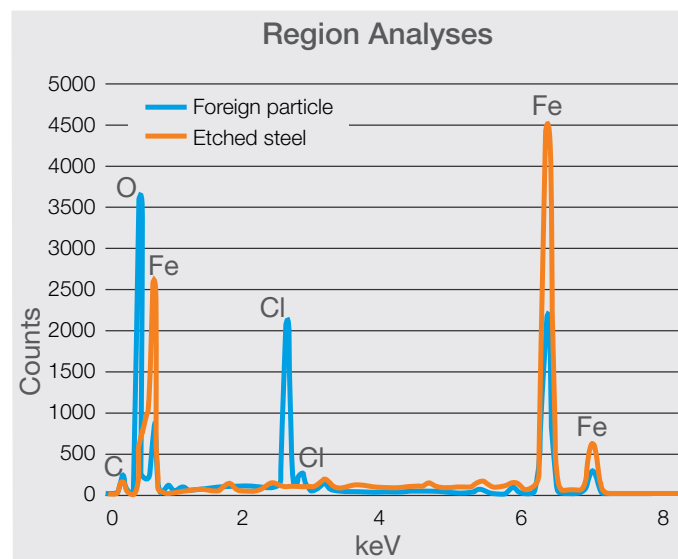
Figure 9. Spectra acquired on the foreign particle and on a clean etched steel surface. The comparison shows the presence of the chlorine peaks (the main peak ($K\alpha$) is visible at 2.621 keV) and a higher content of oxygen ($K\alpha$ at 0.525 keV) in the foreign particle (Acc voltage 15 keV, beam current 0.44 nA, acquisition time 30 s).
