#### Case Details

In 2005 the V/Line VLocity 160kph trains and upgraded rail lines were introduced in Australia. During testing the train drivers complained of the sideways movement of the train. Repair crews went out to re-level the track. However when the crews went to the locations indicated by the drivers, based upon the distance along the track, the problem track could not be identified. Engineers 'road the rails' and documented the location of the problem sections. When the repair crews went out to the noted positions they could not identify the problems. A logging solution was thus required to record and tag the precise locations of problem tracks.

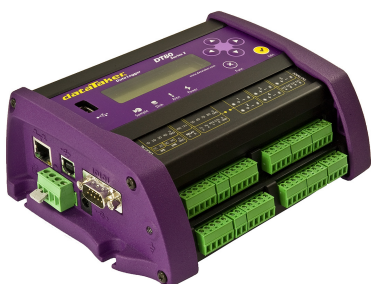
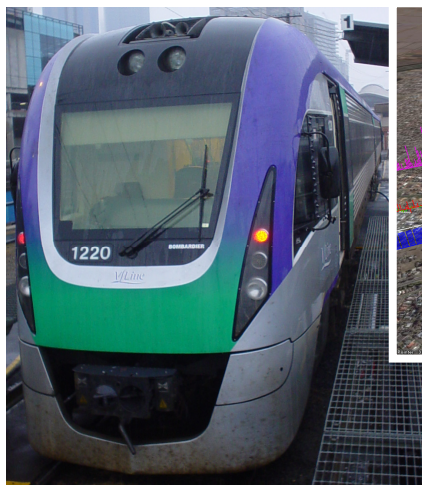
**VLocity train and 3D maps:** The traces represent data gathered at specific GPS coordinates along the train track. The purple bars specifically represent the propensity of the train to derail.

A GPS was connected to the dataTaker CANgate. The CANgate was then connected to a dataTaker DT80 data logger and a tri-axial sensor was connected to an analog channel. The GPS was placed on the roof of the train to give the current train position and the accelerometer would give the instantaneous train vertical and horizontal acceleration of the train at that position.

The results of the train tests were then converted to a Google™ Earth format using a small dataTaker program, for the purposes of plotting 3D geographical data from the dataTaker data logger.
