# XPS Identification of Stains on Split Steel Bearings

**Author** Tim Nunney, Thermo Fisher Scientific, East Grinstead, West Sussex, UK

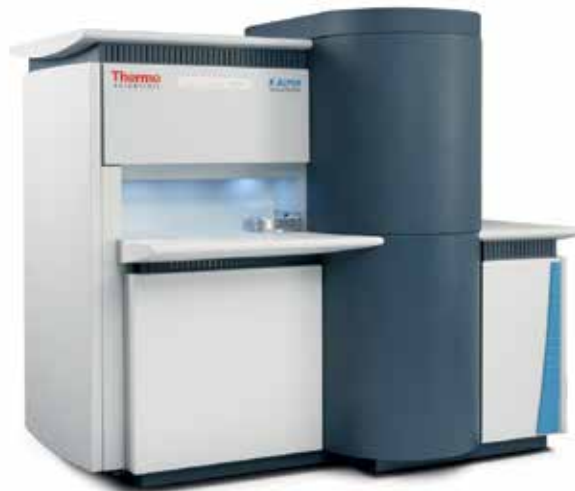
Thermo Scientific K-Alpha XPS

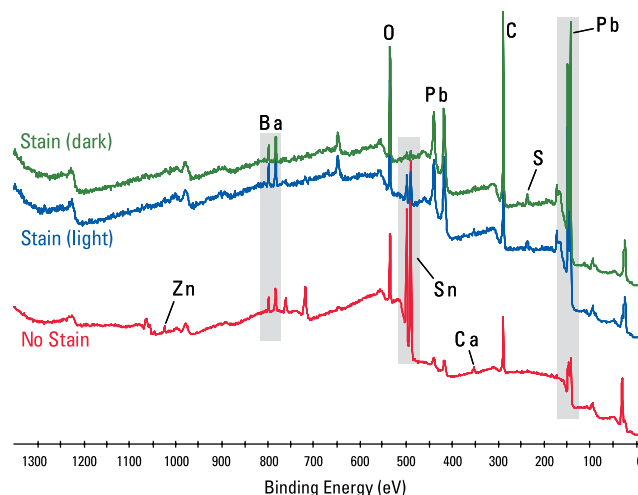
Figure 2: Elemental identification at the three analysis points

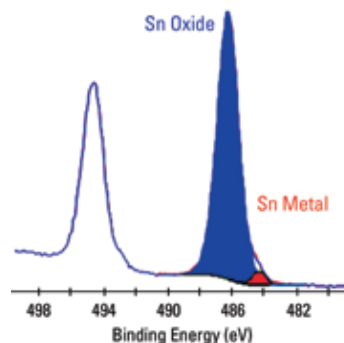
Figure 4: Tin spectrum from unstained area
