Investigating the Mechanism of Defect Formation on Aging Paper

Thermo Scientific K-Alpha

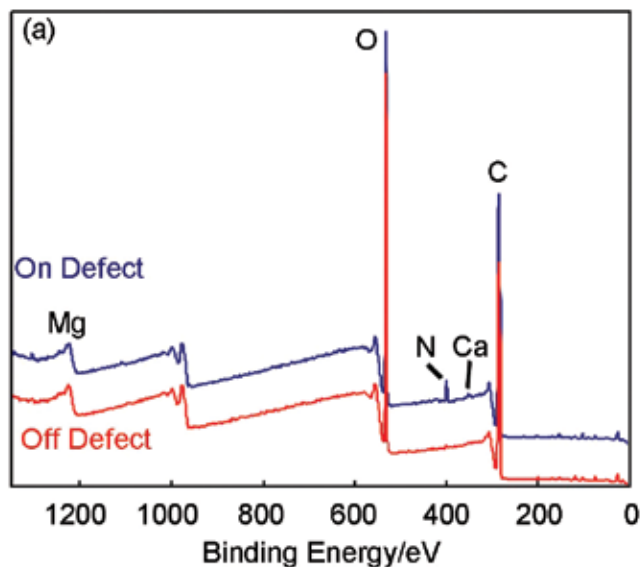
Figure 2: (a) XPS spectra acquired from defect (blue) and off defect (red). (b) Low binding energy region. Spectra have been normalized and offset for clarity.

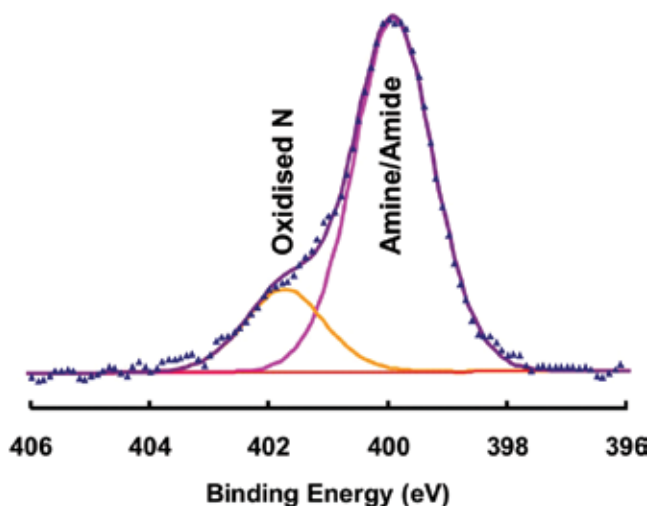
Figure 3: High energy resolution spectrum of nitrogen acquired from defect
